Expanding Conservation/Sediment Control Practices in Priority Farm Areas of the Guánica Bay Watershed

***Final Comprehensive Report
November 29, 2016***

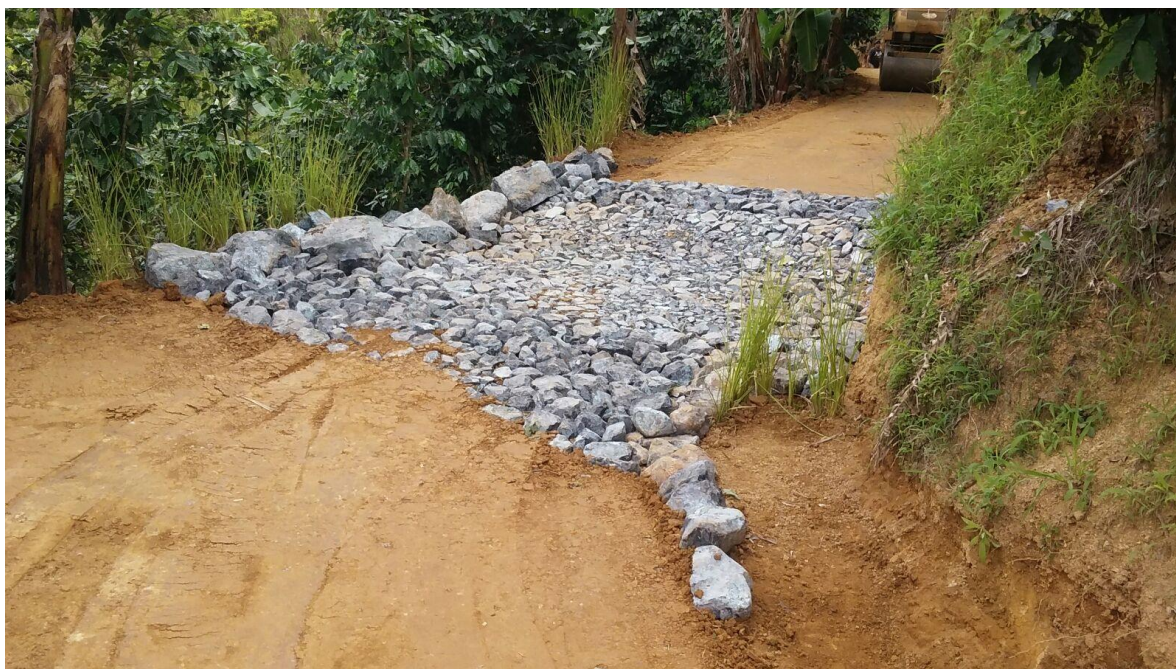
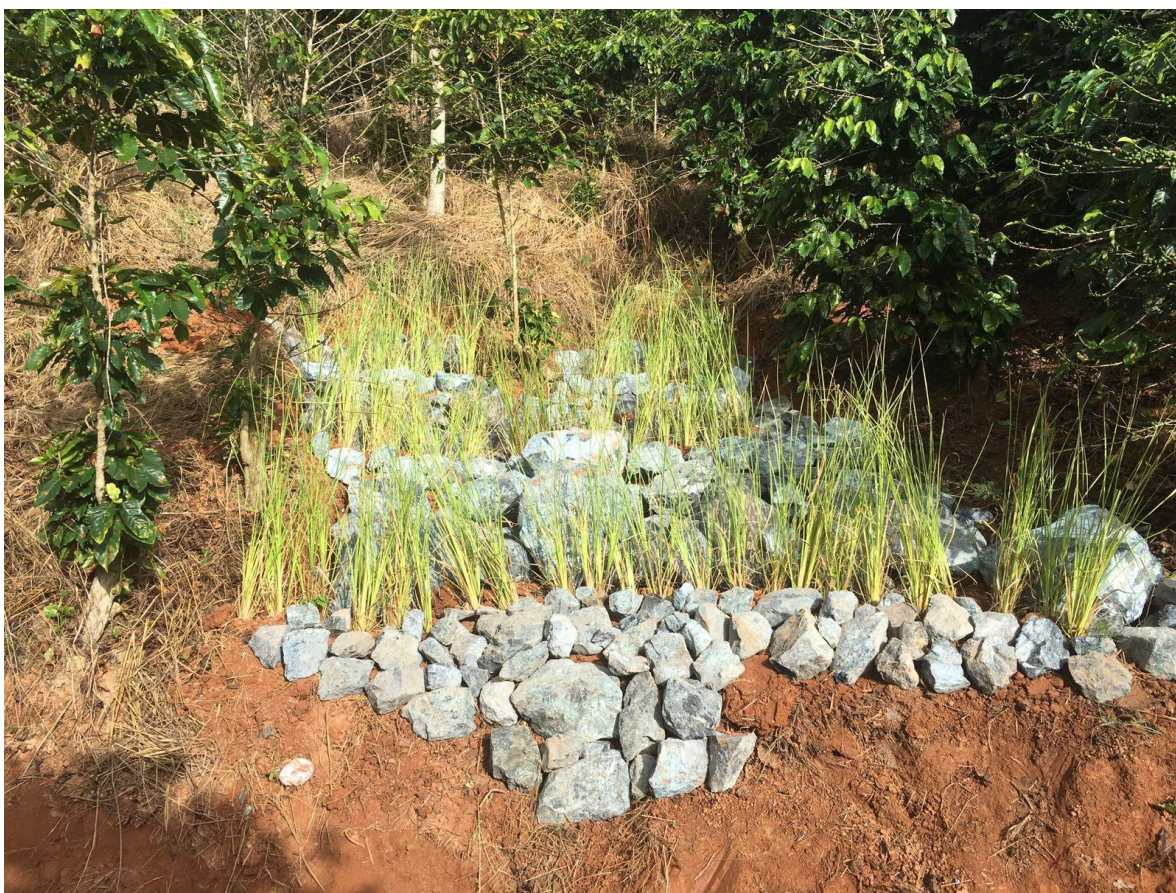
Figure 24. Construction process of rip-rap.

Rip-Rap consists of a permanent sediment and erosion control practice made with resistant ground cover and the use of large angular stones. It is commonly used to protect slopes, streambanks, channels, or areas subjected to erosion by wave action. Rock rip-rap protects soil from erosion due to concentrated runoff. It is used to stabilize slopes that are unstable due to seepage. It is also used to slow the velocity of concentrated runoff which in turn increases the potential for infiltration. In our case, rip-rap was used to protect sediment trap constructed berms and in overflows. In the sediment traps, rip-rap provided some water quality benefits by increasing roughness and decreasing the velocity of the flow, resulting in better settling of particulates. In other areas, we used rip-rap in existing water ways and it offered an easy-to-use method for decreasing water velocity and protecting slopes from erosion. It is simple to install and maintain (Figures 22-24).

constraints but we don't recommend cutting back on this as it is needed for the long-term effectiveness of the practice. Properly sized bedding or geotextile fabric is needed to prevent erosion or undermining of the natural underlying material. Another recommendation is to use hydroseeding on the areas prior to installing the stones. The rock should be placed as soon as possible after disturbing the site, before additional water is concentrated into the drainage system. Over all, rip-rap is cost effective and easy to install, requiring only that the stones be manually arranged so that they remain in a well-graded mass. Where possible, rip-rap should be combined with bioengineering techniques. In our case, in the areas that was feasible, we intersected rip-rap with lines of Vetiver grass.

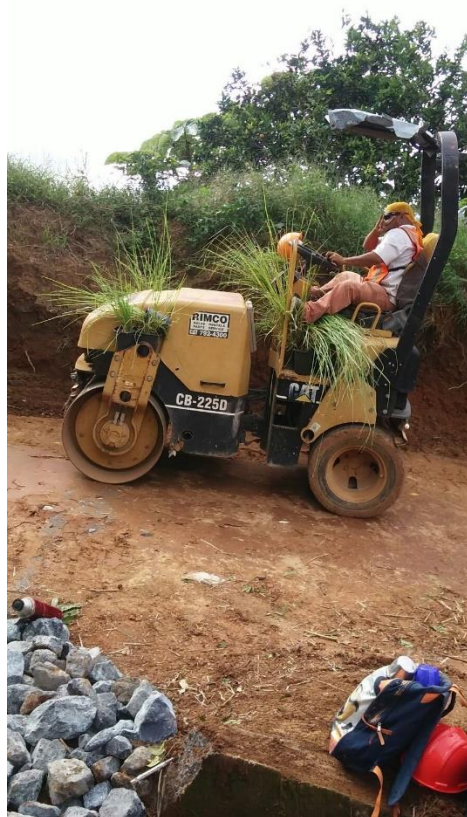
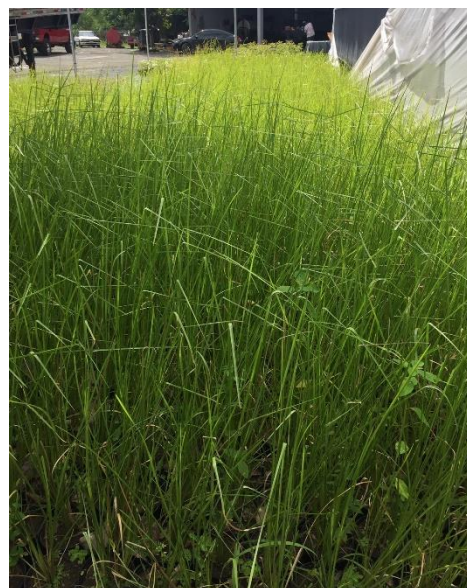
Figure 25. Use of vetiver grass during BMP implementation.

Vetiver grass is a very simple, practical, inexpensive, low maintenance and very effective means of soil and water conservation, sediment control, land stabilizations and rehabilitation, and it also can be used in phyto-remediation practices. When planted in a linear pattern or in half-moons, vetiver plants will form a vegetative mass which is very effective in slowing and spreading run off water, reducing soil erosion, conserving soil moisture and trapping sediment on site. The extremely deep and massively thick root system of Vetiver binds the soil and at the same time makes it very difficult for it to be displaced under high velocity water flows. This very deep and fast growing plant can also tolerate extreme drought conditions as well as moderate soil salinity concentrations with a highly effectiveness on steep slope stabilization. Since we first started using it on coastal restoration projects it has become one of our most common practices implemented due to

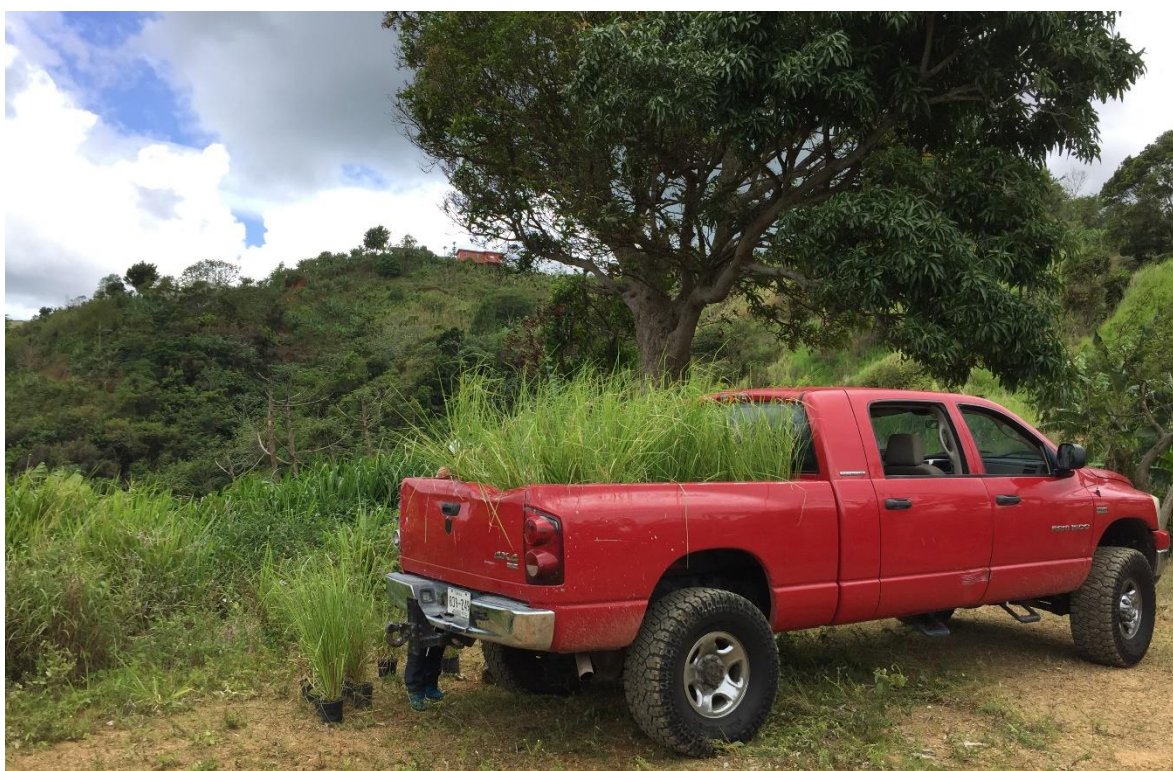
Figure 26. Use of vetiver grass during BMP implementation.

In this effort, we have used it on check dams, sediment traps, rip-rap and on stabilizing soil banks on the side of the dirt road system we have worked on. In combination with other practices such as using proper size stones, it has demonstrated to be the most cost effective technique we have implemented (Figures 25-27). The most commonly available Vetiver plant material comes in small plots, but the best and more rapid results are achieved when plots are transplanted to a 1 gallon pot and grown for no less than 3 months. Because of this technique, planted Vetiver grass, responds more rapidly and adapt to the site's climate condition in a more efficient way with less maintenance period.

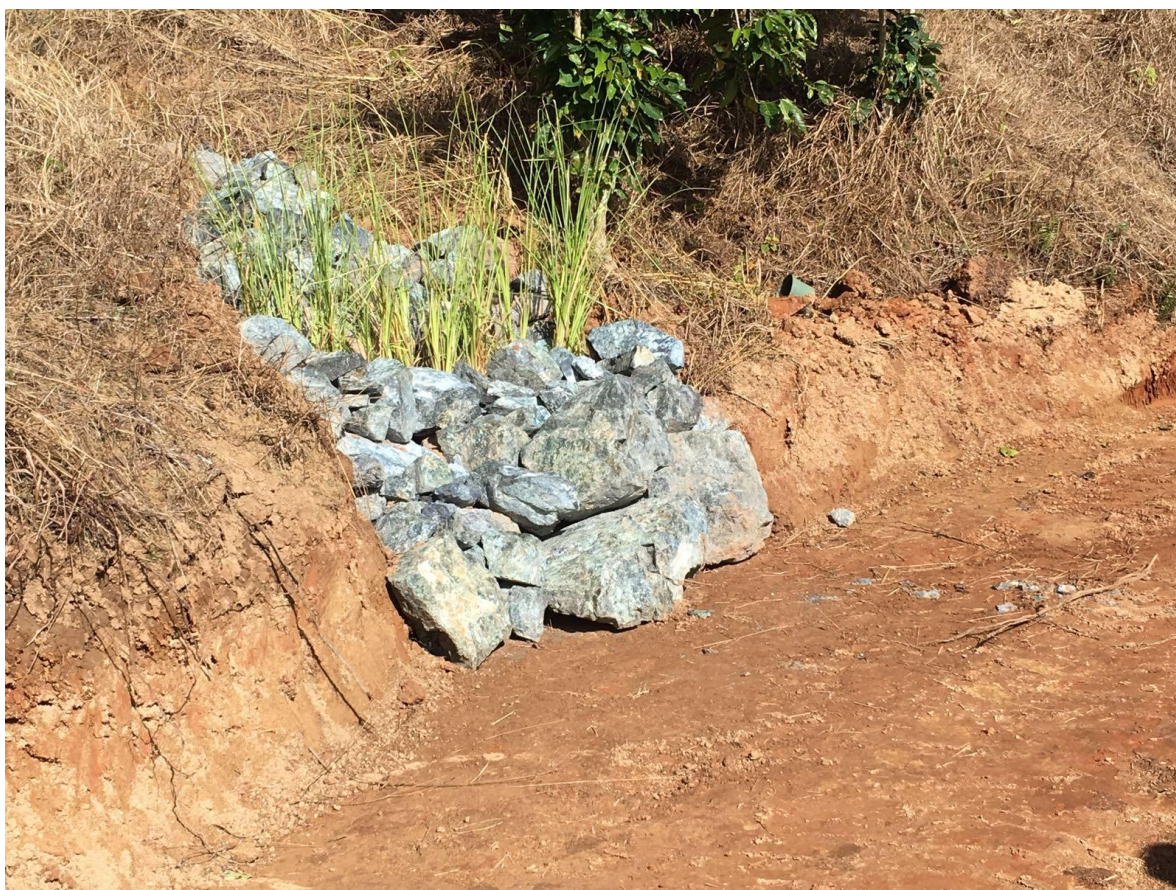
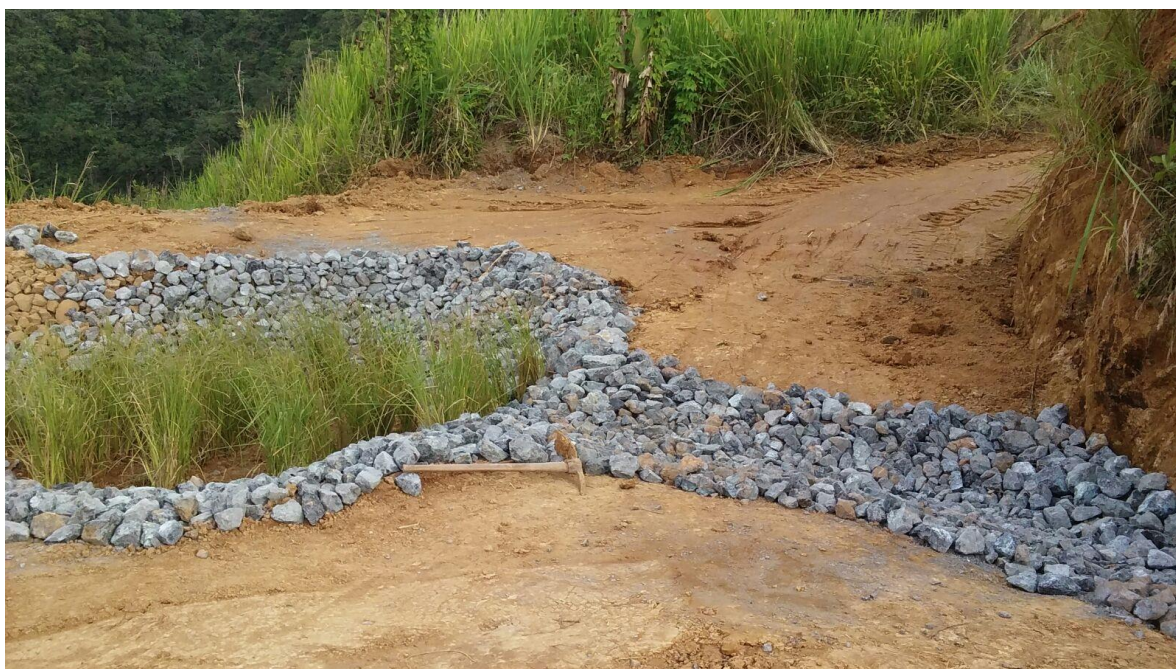
Figure 27. Use of vetiver grass during BMP implementation.

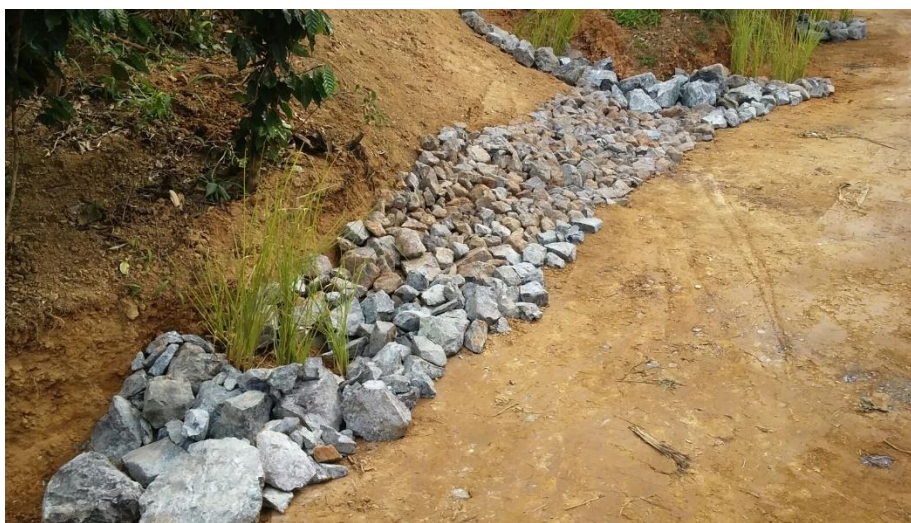
Figure 28. Constructed stone swales during BMP implementation.

Gravel and stone beds are called infiltration trenches or stone swales when used as a stormwater control practice. A swale is a small channel that conveys water from one point to another. When planted with grasses or native vegetation, swales can be very useful in collecting stormwater. There are different types of swales and they can serve various purposes depending on the slope, soil type and the pollutants you will be treating. Swales can be made with stones, vegetative cover, concrete or a combination of all them. In our case we build them to cross water from one part of the road to another or when one road intersects to another crossing the waterway.

This practice can also be very cost effective but, on the selected site they tend to clog fast causing more problems than the ones they solve. We do not recommend this practice for the site location. Concrete swales can be a good alternative to implement in future projects. Concrete swales may be more expensive at the short term but on the long run they will be feasible by the savings on maintenance (Figures 28-29).

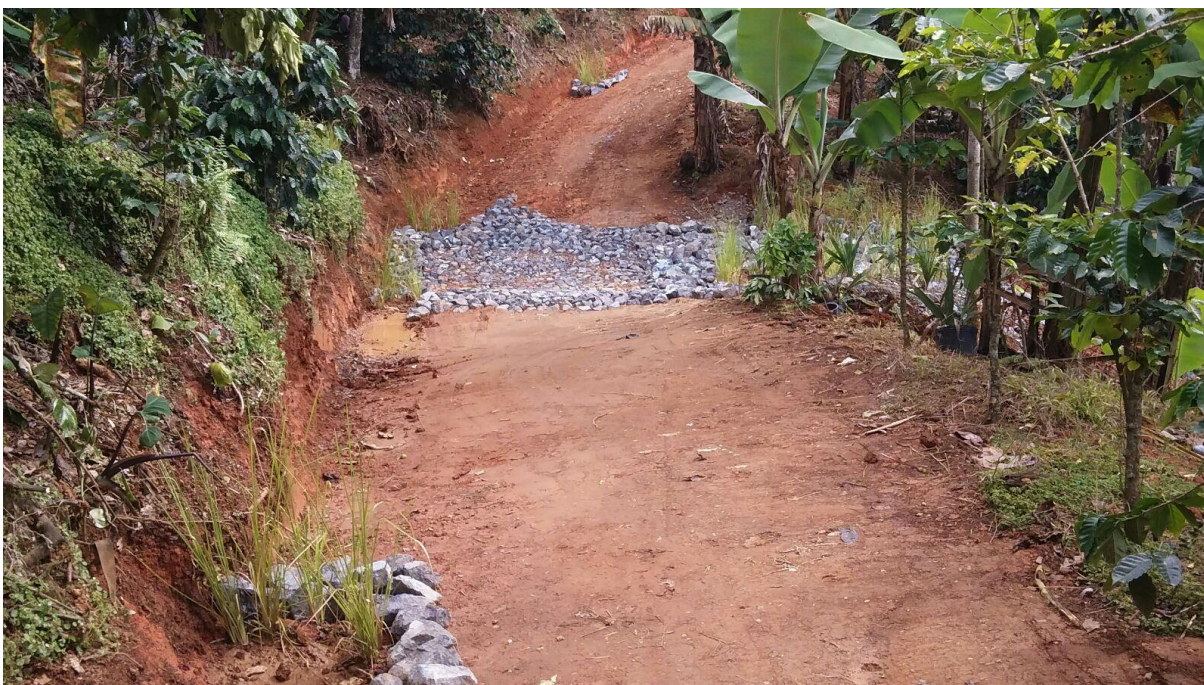
Figure 29. Constructed stone swales during BMP implementation.

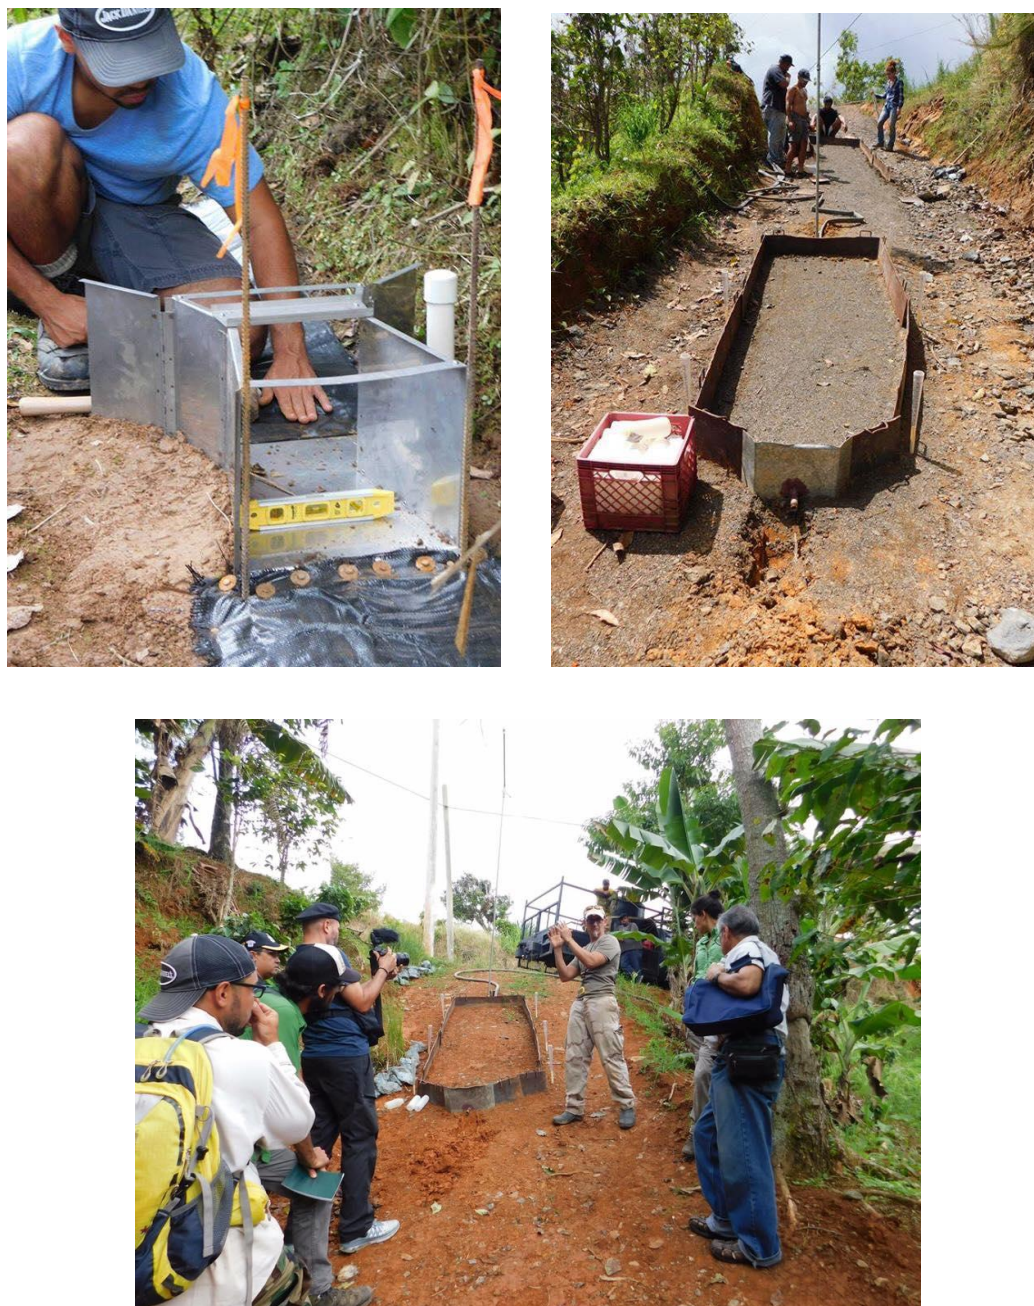
Figure 31. Rain simulation experiments during BMP training sessions at San Carlos Farm.

A study published in *Land Degradation and Development* by Ramos-Scharrón and Thomaz in 2016 describes the methodology used during the BMP training sessions (Figure 31) that took place in San Carlos Farm. Rainfall simulations experiments conducted to quantify runoff and soil erosion from different land surface types, including unpaved roads within farms. Water samples were collected to measure sediment concentration levels and compare them to samples taken in other areas of the farm where bare soils are not exposed. Results of the published 2016 study indicated that bare soil dirt roads within farms begin to mobilize and transport sediment with less than 0.1 cm of rainfall within 1 to 2 minutes into the simulations, with an average of 69 g of sediment eroded during 30 minutes of simulation. Authors concluded that unpaved roads account for over 90% of the eroded sediment reaching the watershed.
